**MALINE CREEK ASBESTOS
SITE CLOSURE AND
STREAMBANK STABILIZATION
STUDY**

ST. LOUIS, MISSOURI

July 1993

TapanAm associates, Inc.

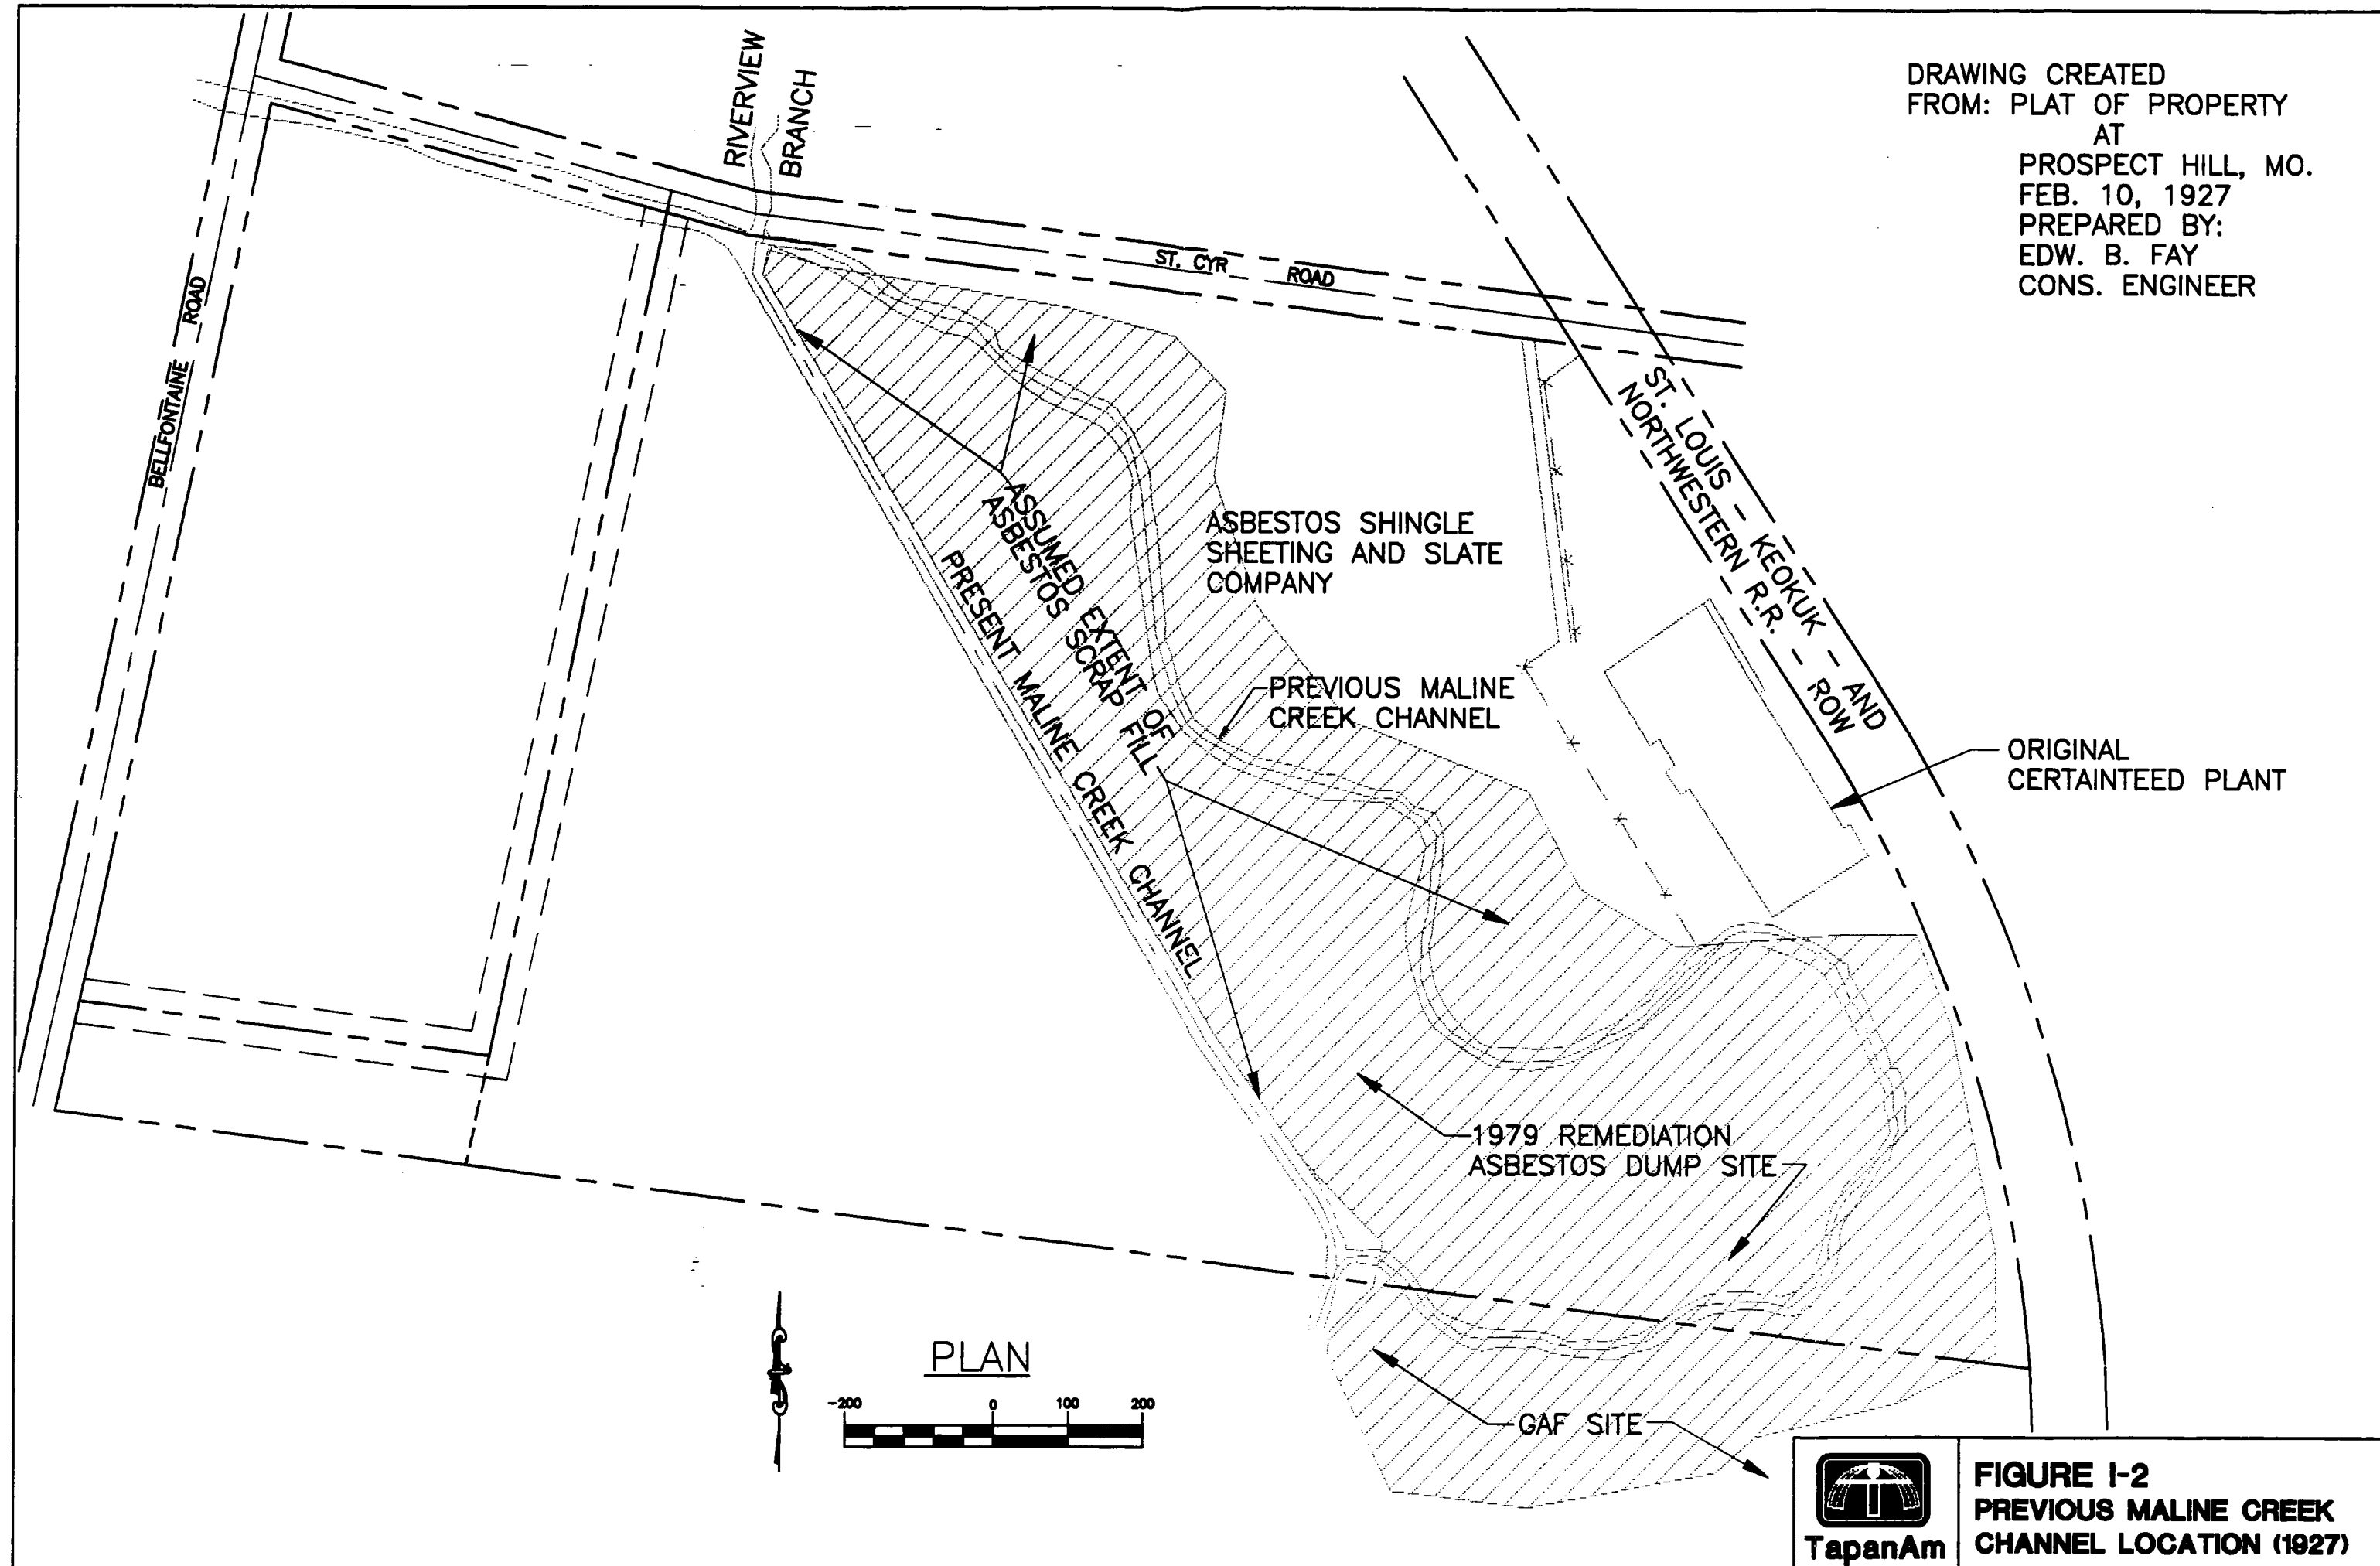
DRAWING CREATED
FROM: PLAT OF PROPERTY
AT
PROSPECT HILL, MO.
FEB. 10, 1927
PREPARED BY:
EDW. B. FAY
CONS. ENGINEER

Before 1927 Maline Creek described a casual meandering path through the site including one horseshoe bend (Figure I-2). The channel was later relocated and straightened to create useable space and to provide a low lying area for a dump site. Subsurface soil borings made by PSI during a TapanAm site visit in December of 1992 suggest that the

entire length of the channel bed fronting the former Certainteed property may be filled with asbestos scrap (See Appendix A). The horseshoe bend which was located between the Certainteed and GAF factories is the closure site for the asbestos scrap pile remediated in 1979.

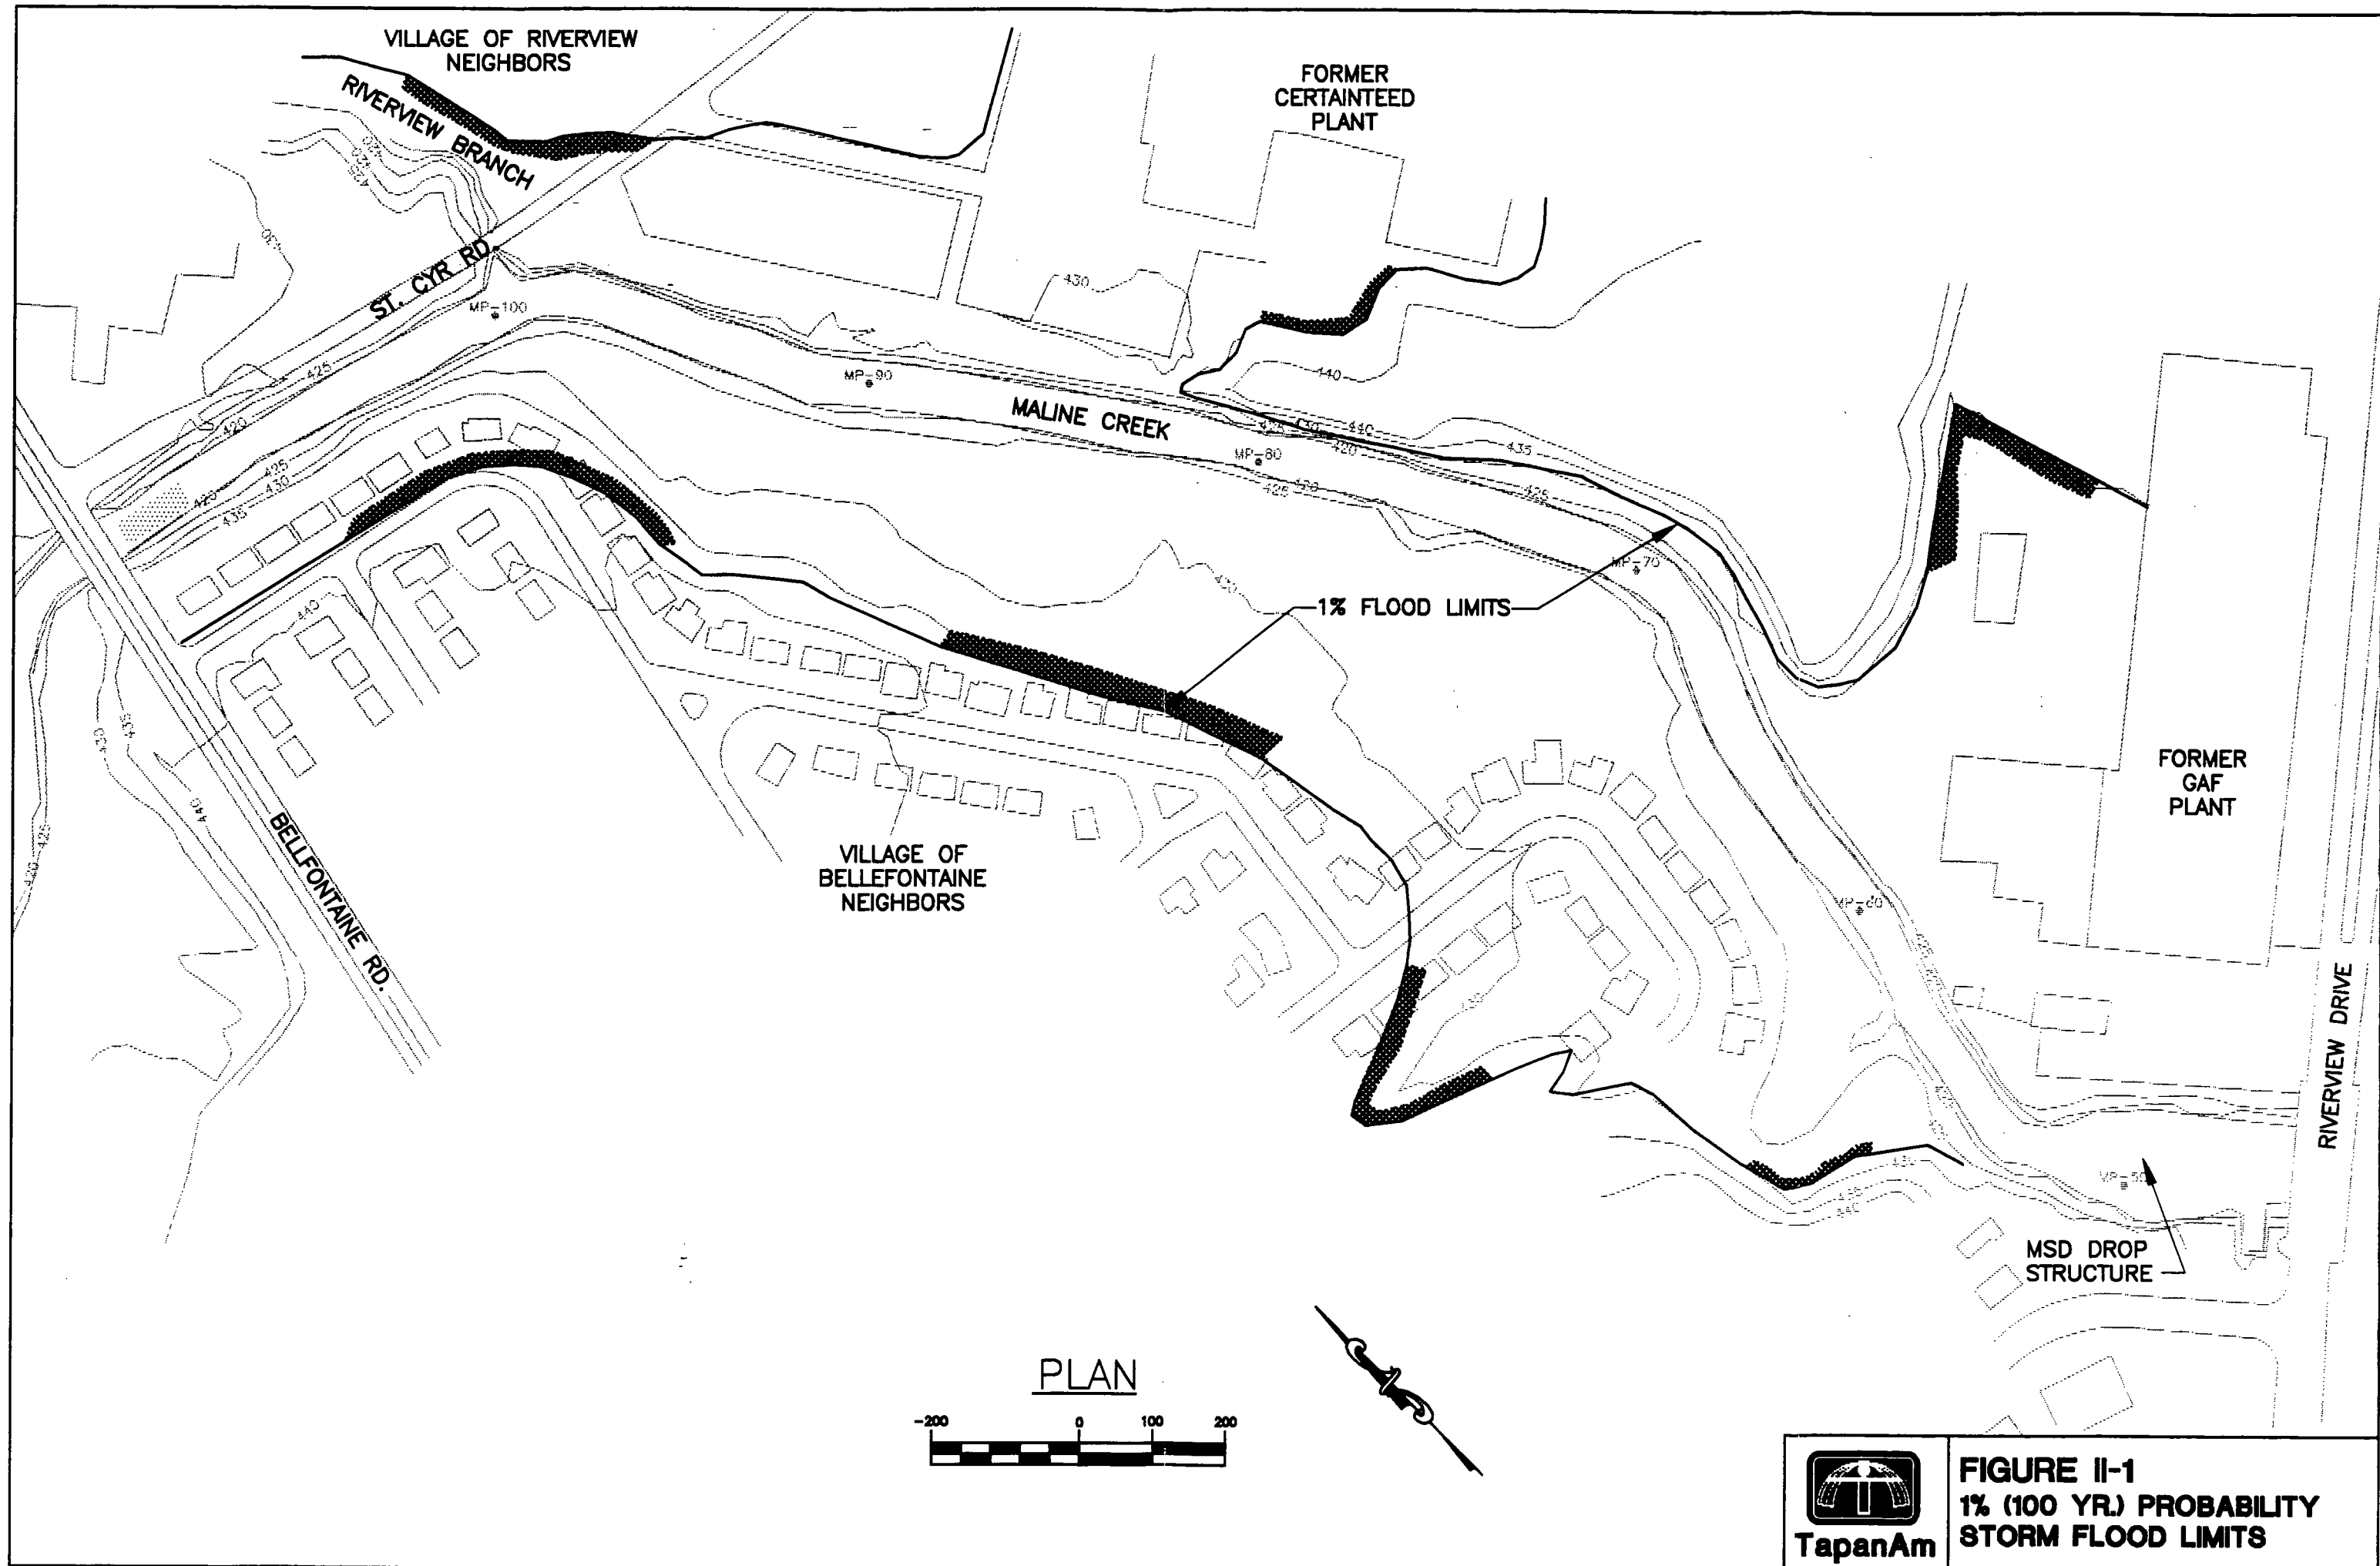
FIGURE II-1
1% (100 YR.) PROBABILITY
STORM FLOOD LIMITS

The Metropolitan Sewer District Drop Structure at Station 0.527 miles is the point of control for water surface profiles along the Maline Creek reach adjoining the Certainteed-GAF asbestos fill sites. Throughout the reach, flow is severely restricted as a result of low conveyance due to mild channel slopes ($<0.2\%$); inadequate cross sectional area; irregular (non prismatic) sections and transitions; and the presence of natural and man placed roughness elements such as brush, trees, rocks, failed riprap, construction debris, asbestos cement pipe, buildings, etc. Discharge through the channel is, therefore, in the subcritical flow regime and results in flooding conditions for storms of 10% probability (10 year) or greater. Extensive flooding is seen during the 1% (100 year) event when most of the Certainteed-GAF site and much of Bellefontaine Neighbors west of the creek are inundated (Figure II-1).

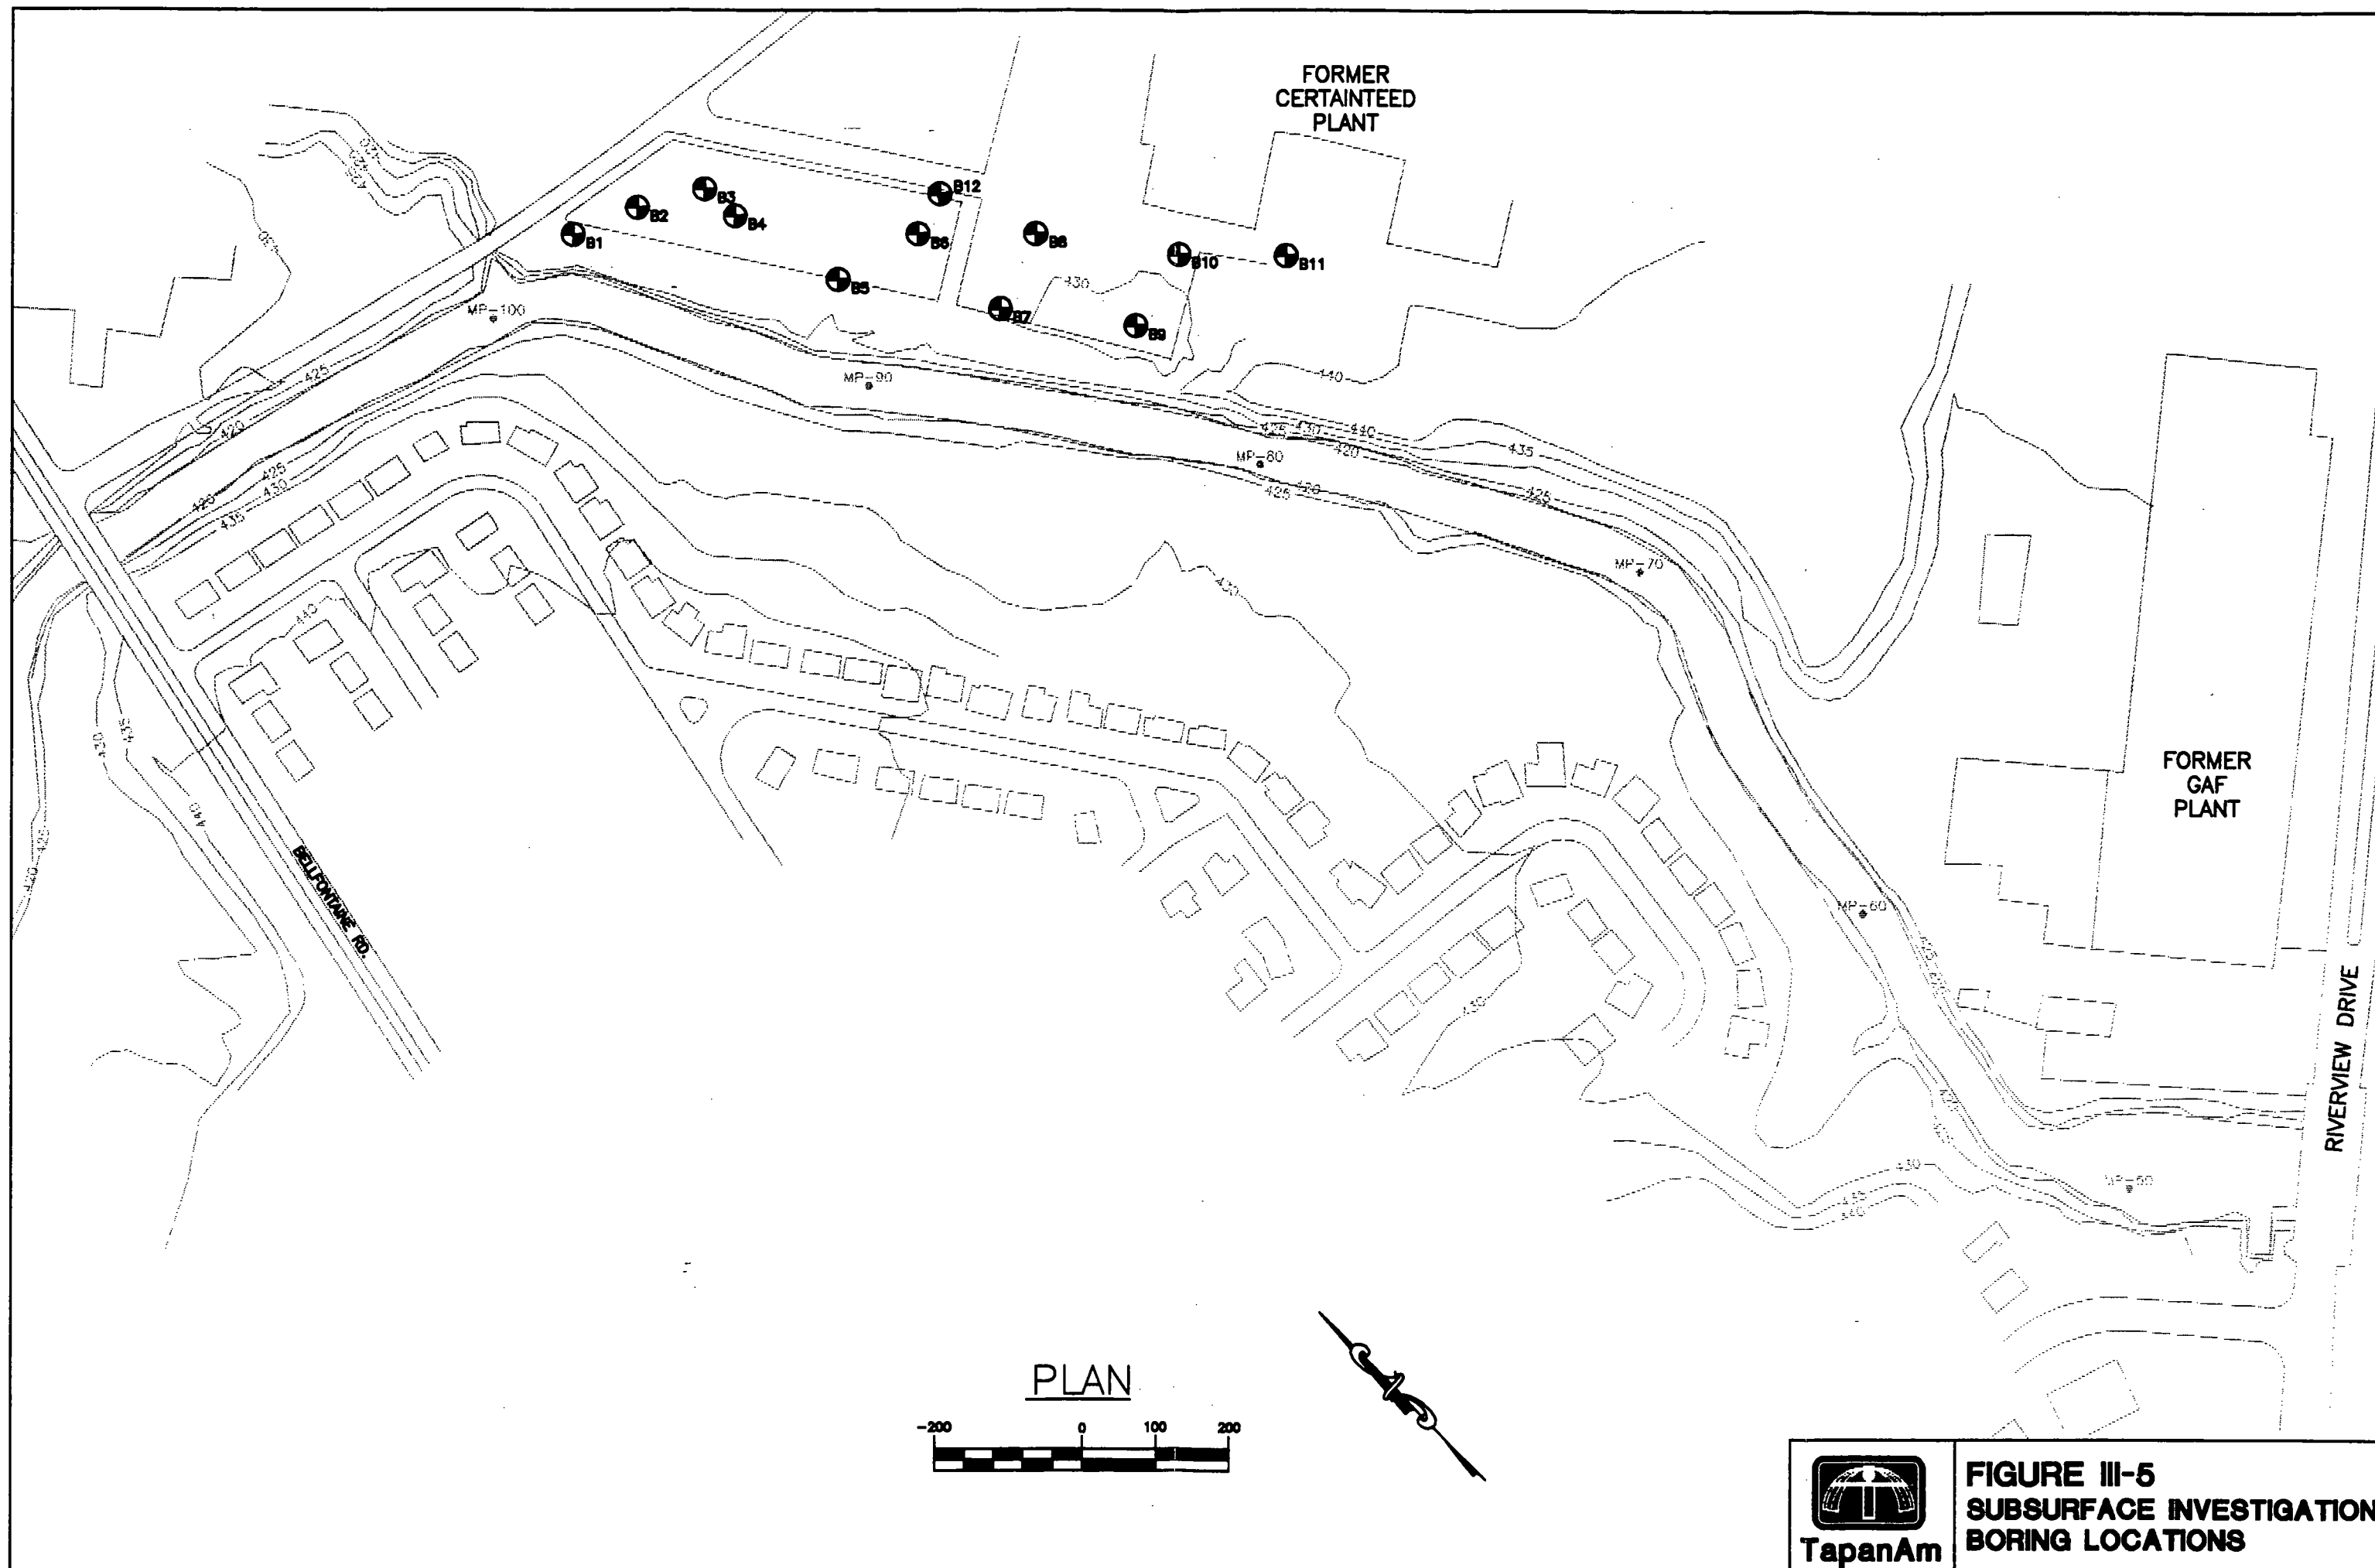
Materials encountered in the boring consisted of fill materials overlying alluvial deposits consisting of silty clays and silts. The fill material consisted of cement asbestos debris, sand, gravel and silty clays.

It is evident from the borehole data that much of the fill material used during the 1927 creek re-alignment project consisted of cement asbestos debris. The thickness of the asbestos bearing fill material ranged from seven feet to the full twenty feet depth of the boring. Fourteen feet of asbestos material was encountered at boring location B1, twenty feet at boring location B4 and eight feet of asbestos material at boring location B8. The soil cap covering the asbestos debris varied from one to two inches in the north to six to seven feet in the south at boring location B6.
